Draft Translation 624  
July 1977

# CONSTRUCTION OF FROZEN FILL DAMS IN ARCTIC COASTAL REGIONS

P.A. Grishin et al

LennorNIIProyekt developed plans for different designs of frozen dams for the Arctic coastal regions. Some of them have been built and are operating successfully, while others are not yet complete and are under observation. This article sets forth the results of observations, analysis of deviations from plans during the construction of installations and experience in their operation.

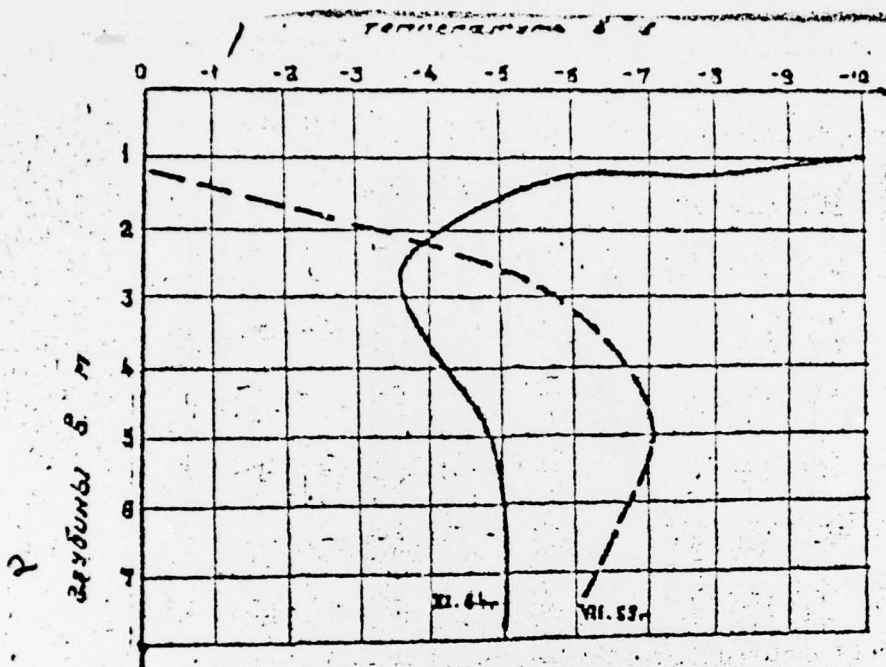
Three thermal drill holes were placed along the crest of the dam for the purpose of monitoring the temperature in the frozen core. The temperatures measured in one of the drill holes are presented in Figure 3.

Figure 3. Temperature distribution through depth of dam.  
Key: 1, Temperature; 2, Depth b, m

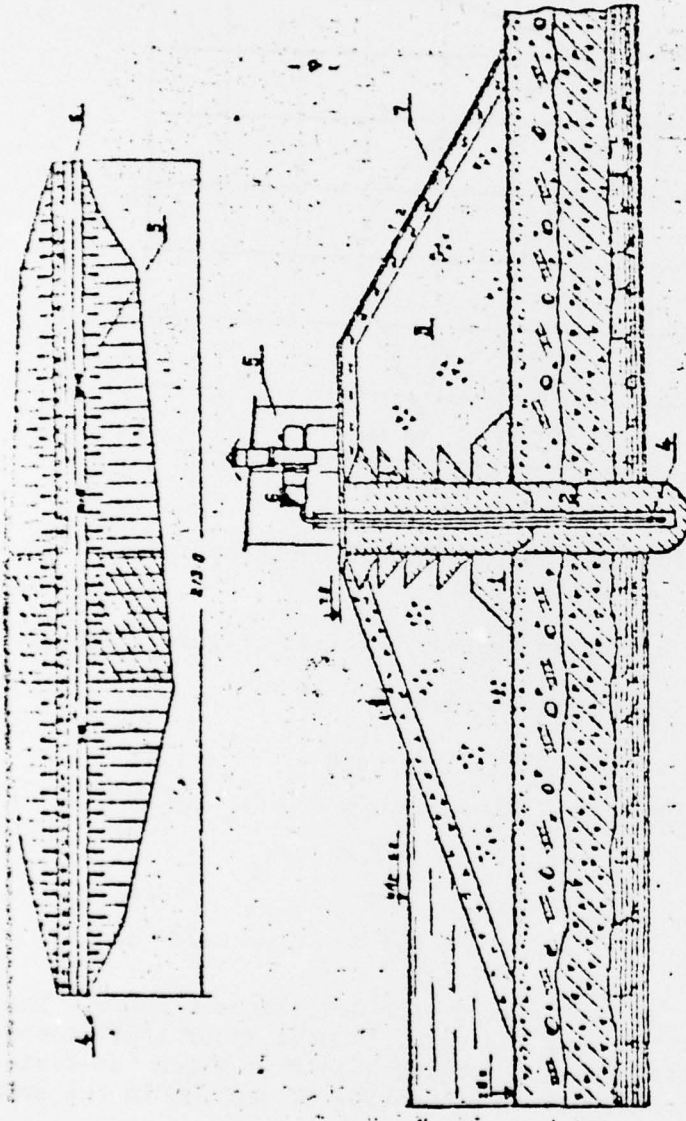
Figure 4. Plan and cross section of dam: 1 -- core of dam; 2 -- subsoil [one word illegible]; 3 -- body of dam; 4 -- freezing column; 5 -- ventilation room; 6 -- air duct; 7 -- heat-insulating shield; 8 -- subsidence zone in 1965; 9 -- temperature-measuring hole No. 2; 10 -- temperature-measuring hole No. 1.

of 149, and the space between them was 2 m instead of the calculated 1.6 m. Thus, the cylinders of frozen soil did not come into contact and the frozen ice curtain had holes containing thawed soil.

The air duct was made from pipes with identical diameter with poor-quality welding, and the velocity of the air in the system barely reached 2 m/s, compared with the planned velocity of 7-10 m/s. The placement of the air duct directly above the column interfered with prompt [one word illegible], cleaning and maintenance. All these factors helped to prevent the formation of the frozen curtain, designed to prevent water from filtering through the body and foundation of the dam.

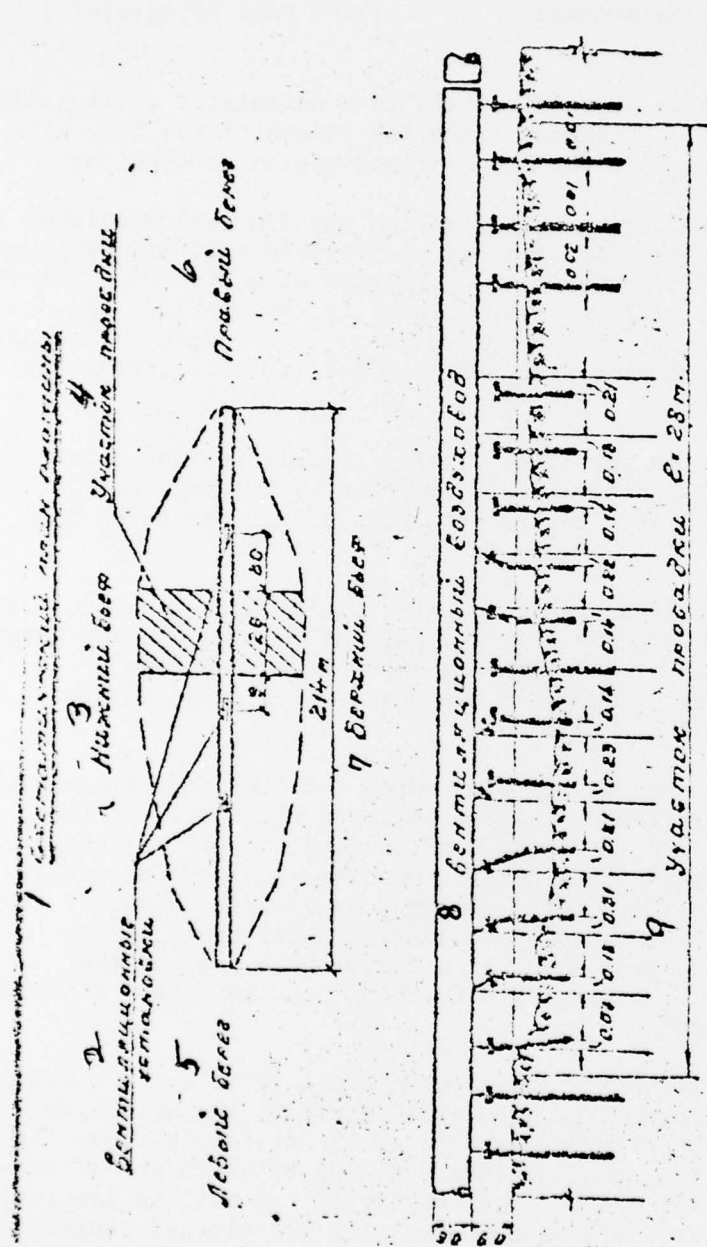
Figure 5. Subsided section of dam.

Key: 1, Schematic plan of dam; 2, Ventilation systems; 3, Lower reach; 4, Subsidence section; 5, Left bank; 6, Right bank; 7, Upper reach; 8, Air ventilation duct; 9, Subsidence section  $l = 28$  m.

Periodic damming promoted the transfer of excess heat to the foundation soil and a buildup of the filtration flow to 20-25  $\text{m}^3/\text{hr}$  and more. Warming of the soils of the foundation resulted in [one word illegible] deformations. By the end of 1965 the dam had settled as much as 0.5 m in a 23-m long section (Figure 5). Up to 0.2-m cracks appeared at subsidence boundaries. Cavities formed through the entire thickness of the body and core of the dam due to uneven settling.

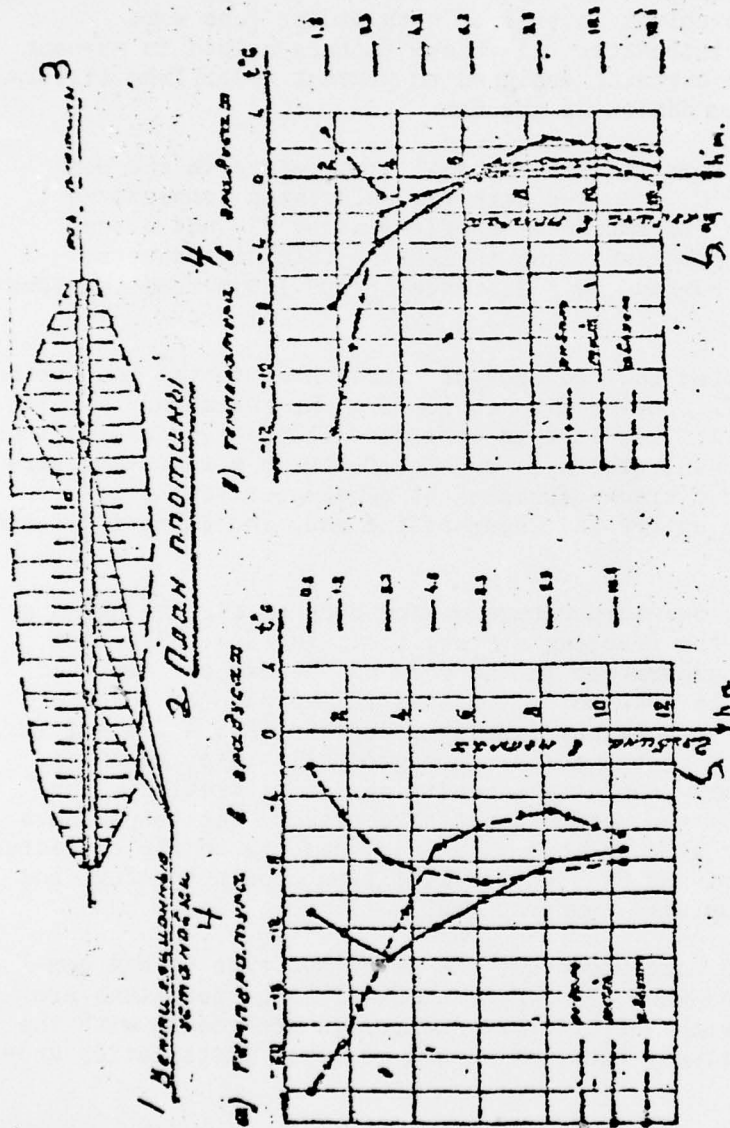
Figure 6. Temperature curves: Left -- temperature hole No. 1; right -- temperature hole No. 2.  
Key: 1, Ventilation systems; 2, Plan of dam; 3, [Possibly axis of dam]; 4, Temperature in degrees; 5, [Possibly depth in meters]. [Remainder of information illegible].

By the beginning of summer in 1965 the soil temperature in the bed part of the dam reached  $1.5^{\circ}\text{C}$ , compared with the calculated temperature of  $-6^{\circ}\text{C}$ . Consequently, the filtration of subfloor water did not cease. This was indicated by the formation of up to 2-meter thick ice sheets, extending over the earth's surface to a distance of 100-150 m from the lower reach of the dam.

Systematic changing of the temperature of the body of the dam began at the moment of operation of the freezing system, i.e., in 1964. The most characteristic changes of temperature in the body of the dam are depicted by the graphs (Figure 6). In hole No. 2, located in the path of [one word illegible] filtration, the soil temperature at a depth of 8.3 m did not fall below  $0.1^{\circ}\text{C}$  in April-May. Then the temperature gradually rose, reaching  $2.3^{\circ}\text{C}$  in August. Consequently, under the conditions of filtration water flow, short-term freezing of the core did not take place. The temperature curve of hole No. 1 shows that [one word illegible] defects of the corrected freezing system, the core of the dam, where filtration does not occur, completely freezes to the calculated temperatures.
